DEPARTMENTAL RESEARCH
GDOT RESEARCH PROJECT NO. 8203
Final Report

WRONG-WAY MOVEMENTS ON PARTIAL CLOVERLEAF RAMPS

Percy B. Middlebrooks, Jr.
Acting Chief, Research and Development Bureau

August, 1988

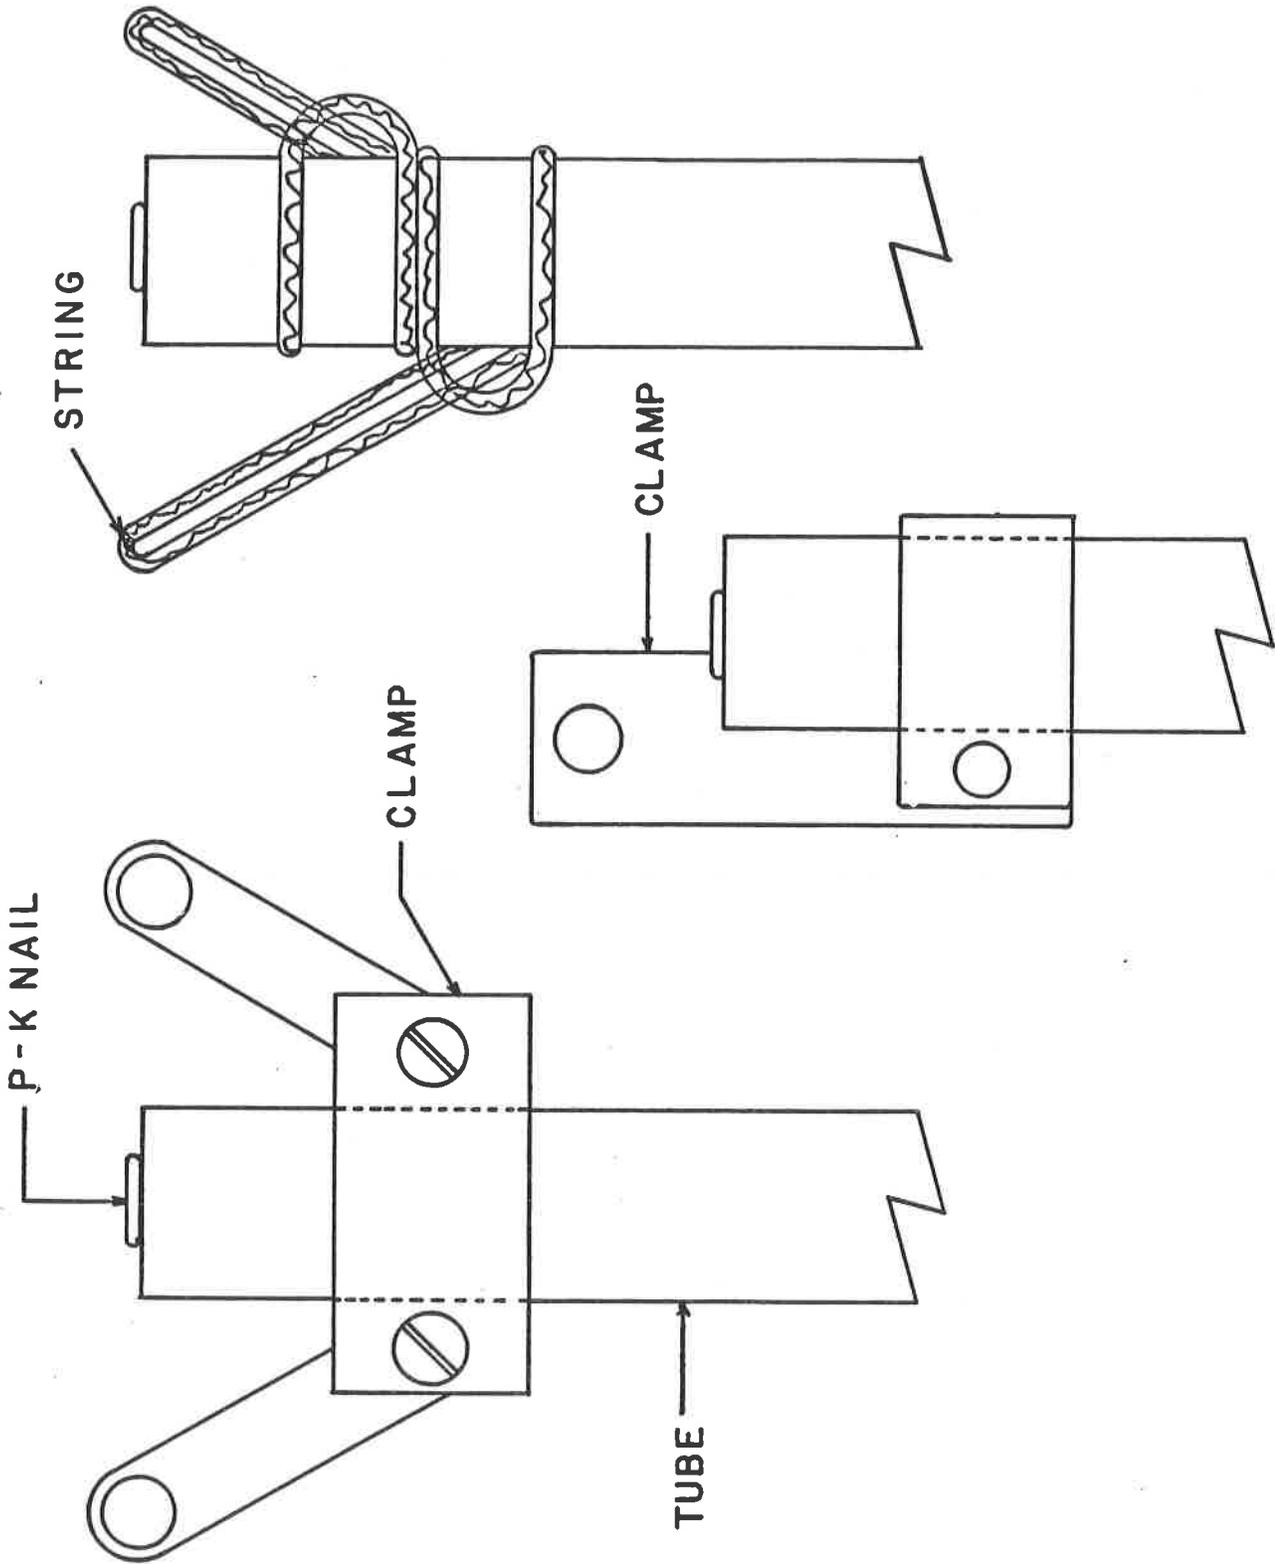
FIGURE 1

There are three different ways to anchor the tubes (Figure 1). Each consists of using a 2½" Parker-Kalon (P-K) masonry nail. When the tubes are secured, there should be enough tension between the anchoring points to keep the tubes from overlapping. On very hot days, this process also causes the

nails to pull out of the asphalt. Six inch gutter spikes may have to be used for anchoring. The far end of the road tubes should be sealed to insure a stronger pulse and also to help prevent the infiltration of water into the tubes. Good results can be had using a P-K nail inserted in the tube; however, some water still gets into the tubes occasionally after heavy rains, and they can be blown out with compressed air.

If the roadway is wide (greater than 2 lanes) or there are many turning movements, then a center clamp (Figure 1) should be installed to reduce the stress on the road tubes. The middle of or between traffic lanes is the best place for the clamp.

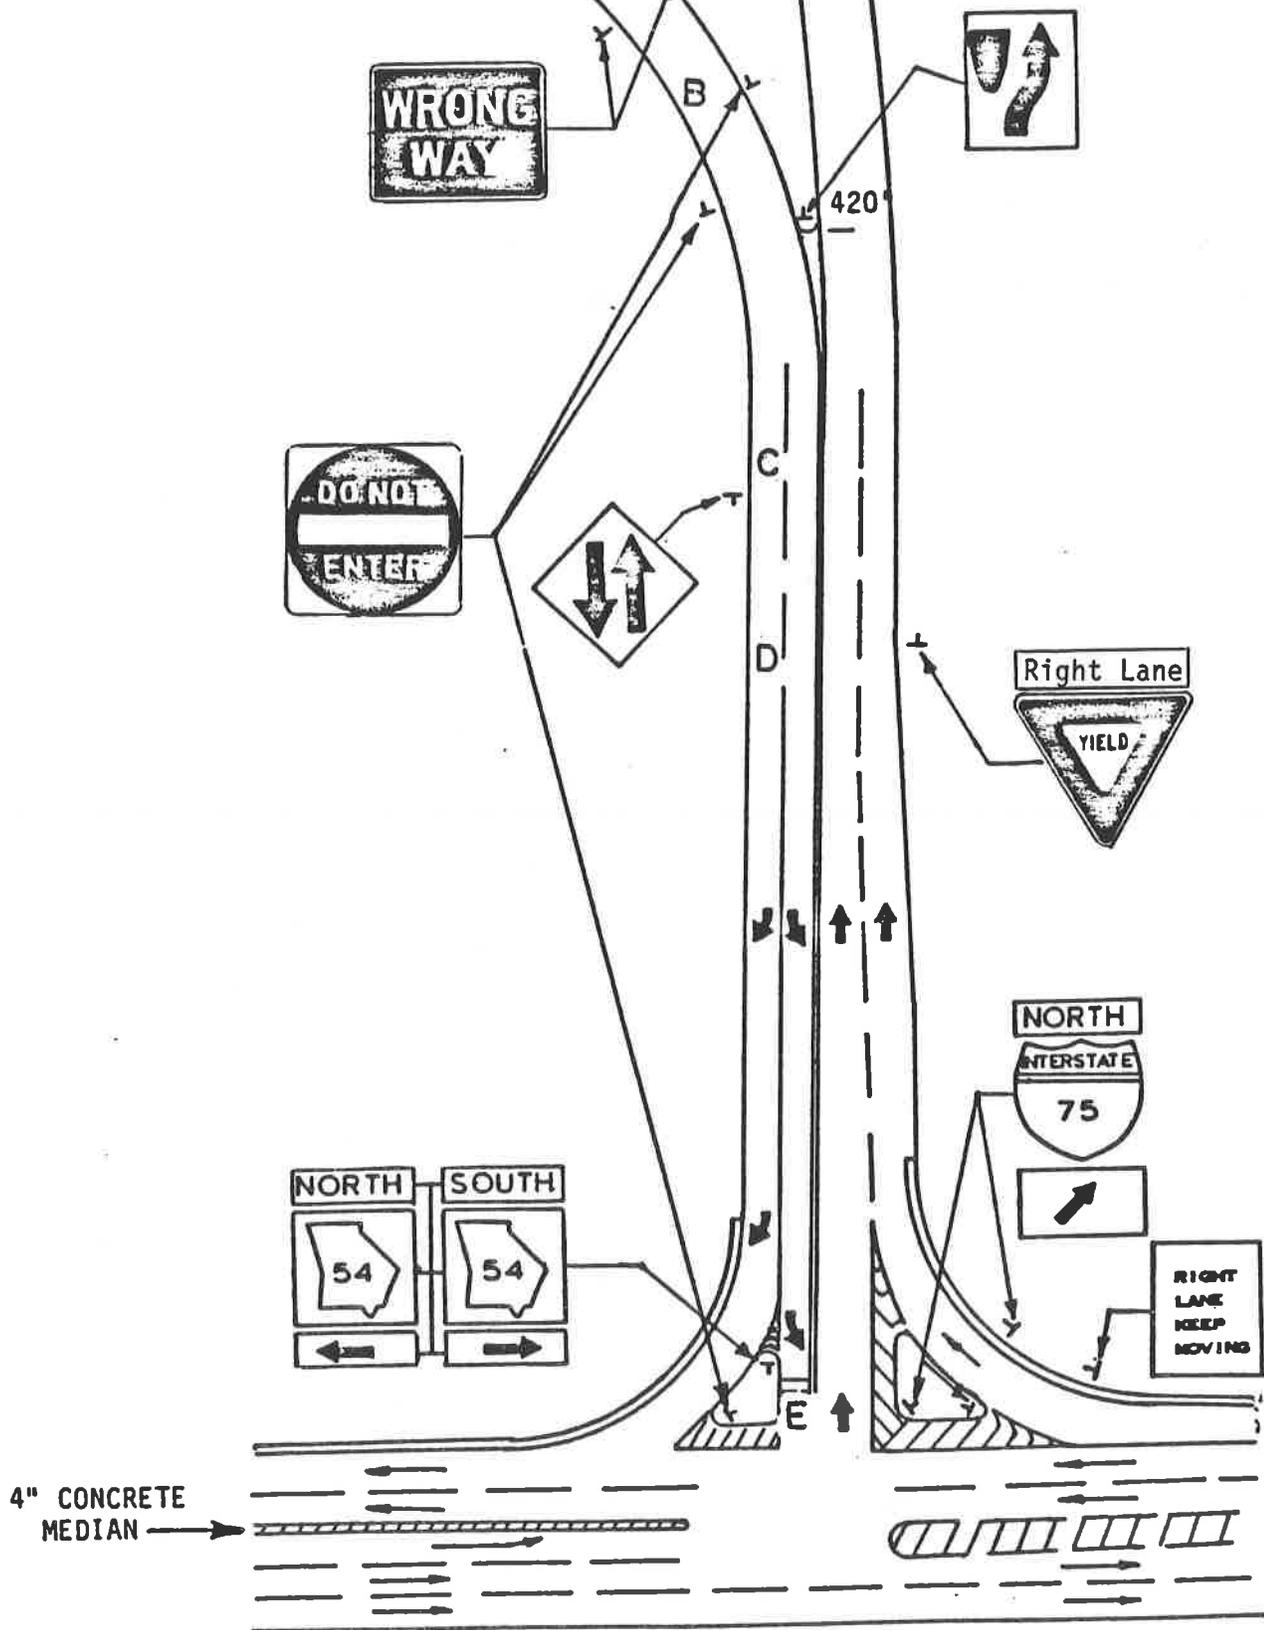
FIGURE 2

JONESBORO ROAD AND I-75 NORTH

The SR 54 partial cloverleaf interchange was known to have a problem with wrong-way movements. A number had been witnessed and people who had accidentally made that movement were known. This location originally had a grass median approximately 25' wide. The grass had been killed by repeated traffic crossing from the exit ramp to the entrance ramp to correct their wrong-way entry. Counts made at this location during widening of Jonesboro Road with standard construction signing in place were 73.3 per 30 day for night and 13.4 per 30 day for day giving a total of 86.7 wrong-way movements per 30-day month.* Construction to combine the ramps was completed in September of 1982. The grass median was eliminated and the exit and entrance ramps were both widened to two lanes each (Figure 2). After reconstruction, the ramps were signed as follows: large pavement arrows in each of the two entrance and exit ramps; double yellow line separating the two ramps, and continued for a distance of 420' down the ramps before the ramps separated; "I-75" trail-blazer signs at the intersection; a "RIGHT LANE YIELDS" sign; and a "KEEP RIGHT" sign at the split of the ramps. Two sets of "WRONG-WAY" and "DO NOT ENTER" signs were located at the exit ramp after the two ramps split. S.R. 54 also has a 4" median to channelize the left turning traffic into the on-ramp. A drawing of the new interchange geometry at SR 54 is shown in Figure 2 and results of the counts are shown in Table 1.

1. GDOT Standard Countermeasures: Two DO NOT ENTER signs; one KEEP RIGHT sign at intersection; two WRONG-WAY signs at Point C; an I-75 NORTH sign across SR-54; two 9' pavement arrows (nearly obscure)
2. Does not include actuations caused by vehicles 1-3 feet over the centerline.
3. See locations on Figure 2.

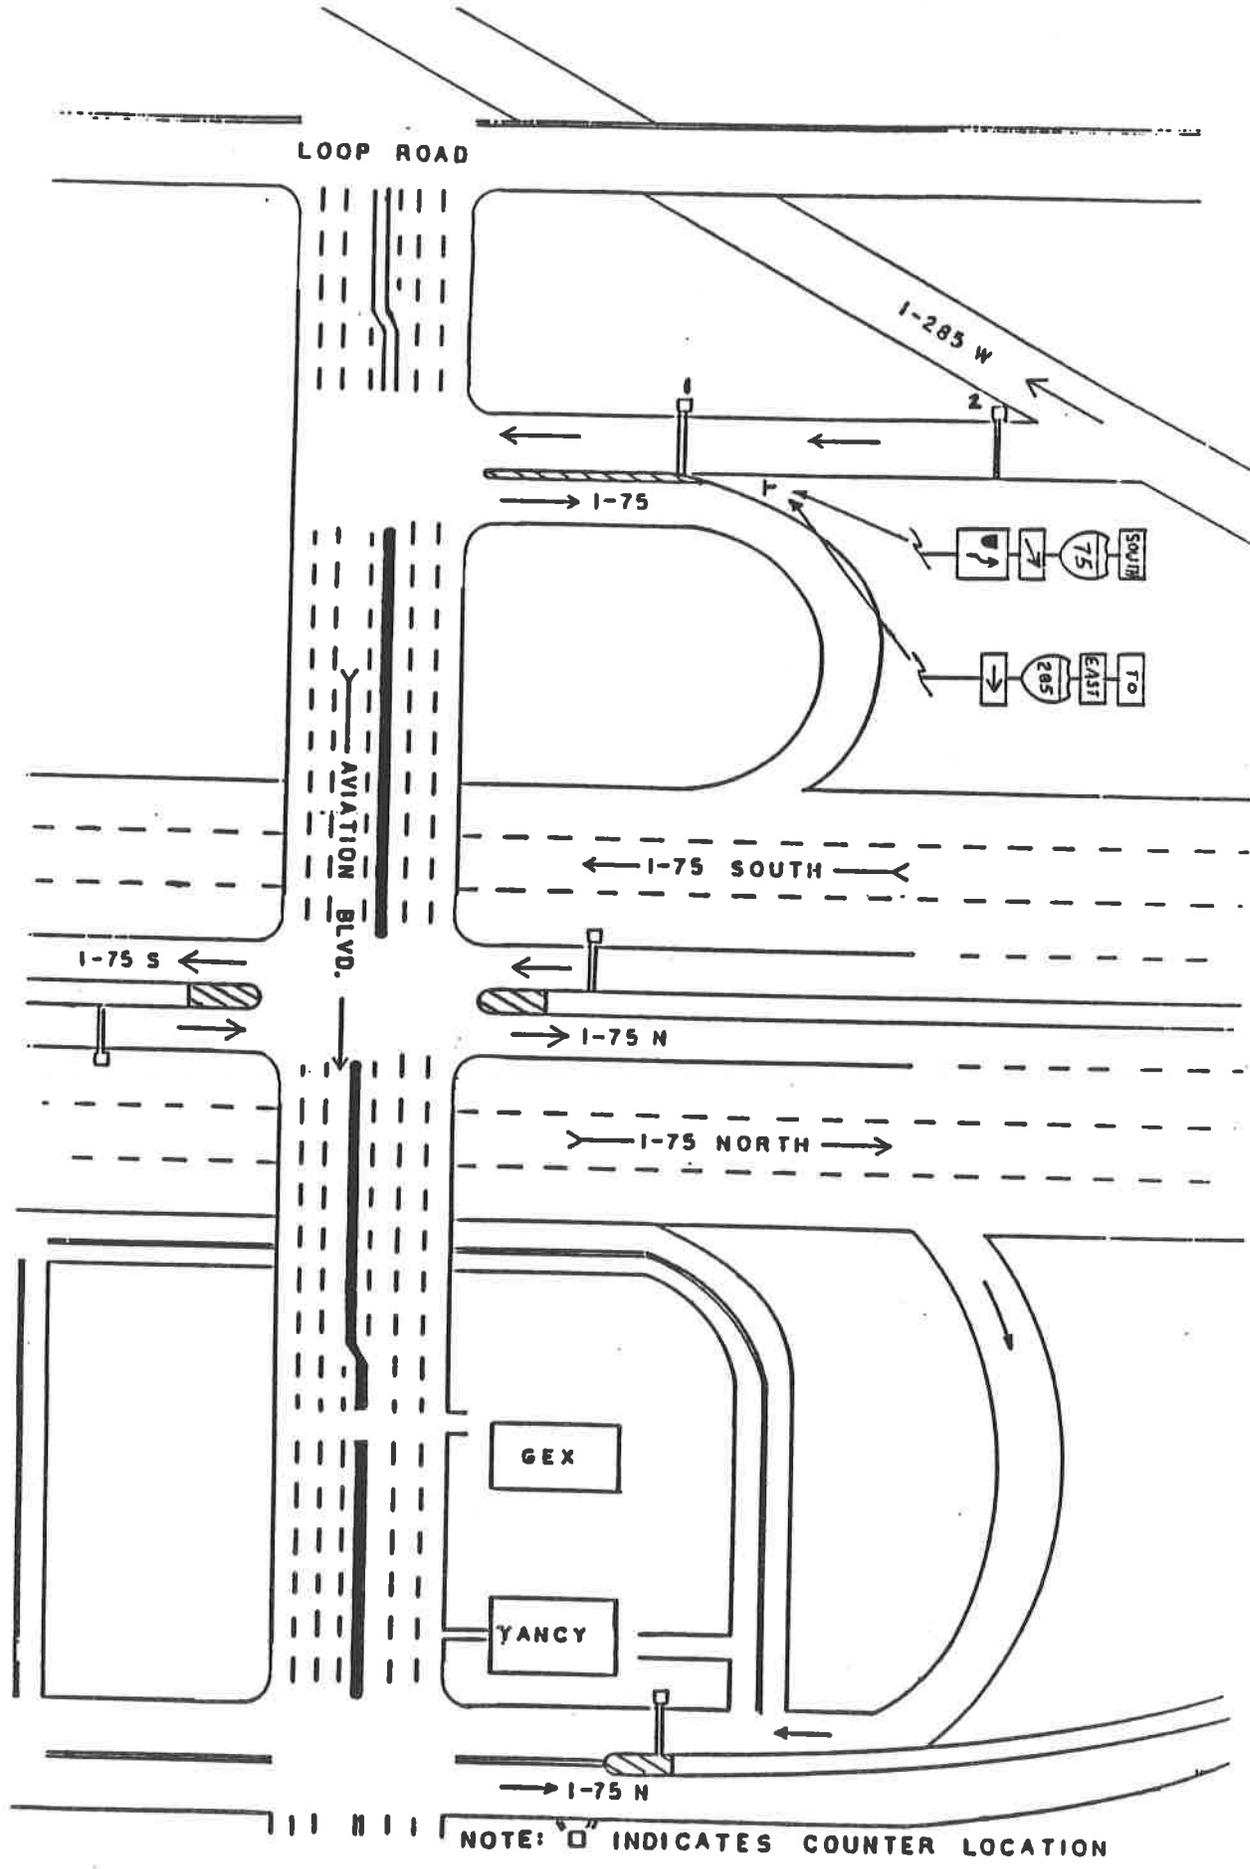
FIGURE 4

NOTE: □ INDICATES COUNTER LOCATION

Aviation Blvd. and I-75 South (Right-Hand Exit, at Intersection of Ramp and Aviation Blvd.)(Figure 4) had the worst wrong-way count rate of any of the ramps that were studied during this project. There were a total of 365 confirmed wrong-way counts, 268 day and 97 night, in 226 days of monitoring.* These counts were collected with the ramps original signing and after two separate temporary changes were made. The original signing within the median is shown in Figure 5. With the original signing there were 126 wrong-way counts in 68 days which was a wrong-way rate of 55.6 per 30 day month. It was found that the interstate directional signs on this ramp were different (Figure 5a). These signs were misleading due to the fact that the same ramp is used to get to both I-75 and I-285. It was suspected that motorists were traveling in the right lane (Figure 4) and that they were switching to the left lane because of the direction of the arrows. The I-75 arrow (Figure 5a)

Approximately two months after monitoring began on the same ramp, a second counter was installed approximately 700 feet further down the ramp (Figure 4). The purpose was to determine the number of motorists that were proceeding the full distance to the I-285 ramp. The initial rate before any signing changes were made was 22.5 per 30 day month. 40.5% of the motorists entering the wrong way were continuing on. After the directional signs were changed, this rate dropped to 12.4 per 30 day month. It was unusual that this rate dropped considering that the counter 700 feet up the ramp showed over a 15% increase. Once the temporary arrows were placed, the 30 day rate dropped to 8.8 which was 25.8% of the wrong-way motorists entering the ramp. This number is still high number for vehicles traveling this distance. Once the motorists passed the second counter, it is not known whether they continued, turned around, or took a short cut to I-285 West (Figure 4).

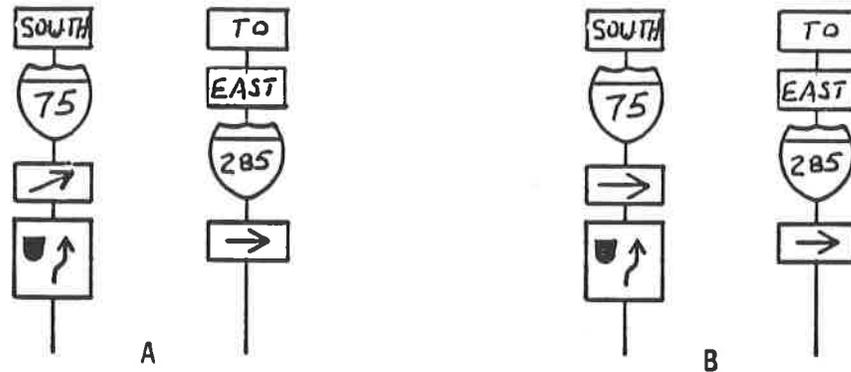
Figure 5

was replaced with a straight arrow (Figure 5b).

The sign change increased the wrong-way rate from 55.6 to 65.9. GDOT monitored this location after the sign change for 56 days and recorded 123 wrong-way counts. On August 8, 1987, temporary Pavement Arrows were placed on both the On-Ramp and the Off-Ramp to determine if this would help alleviate the confusion. The wrong-way rate dropped to 34.1. It was also recommended that the Interstate Sign Assembly be relocated to the right side of the On-Ramp. The sign assembly has not been relocated to date.

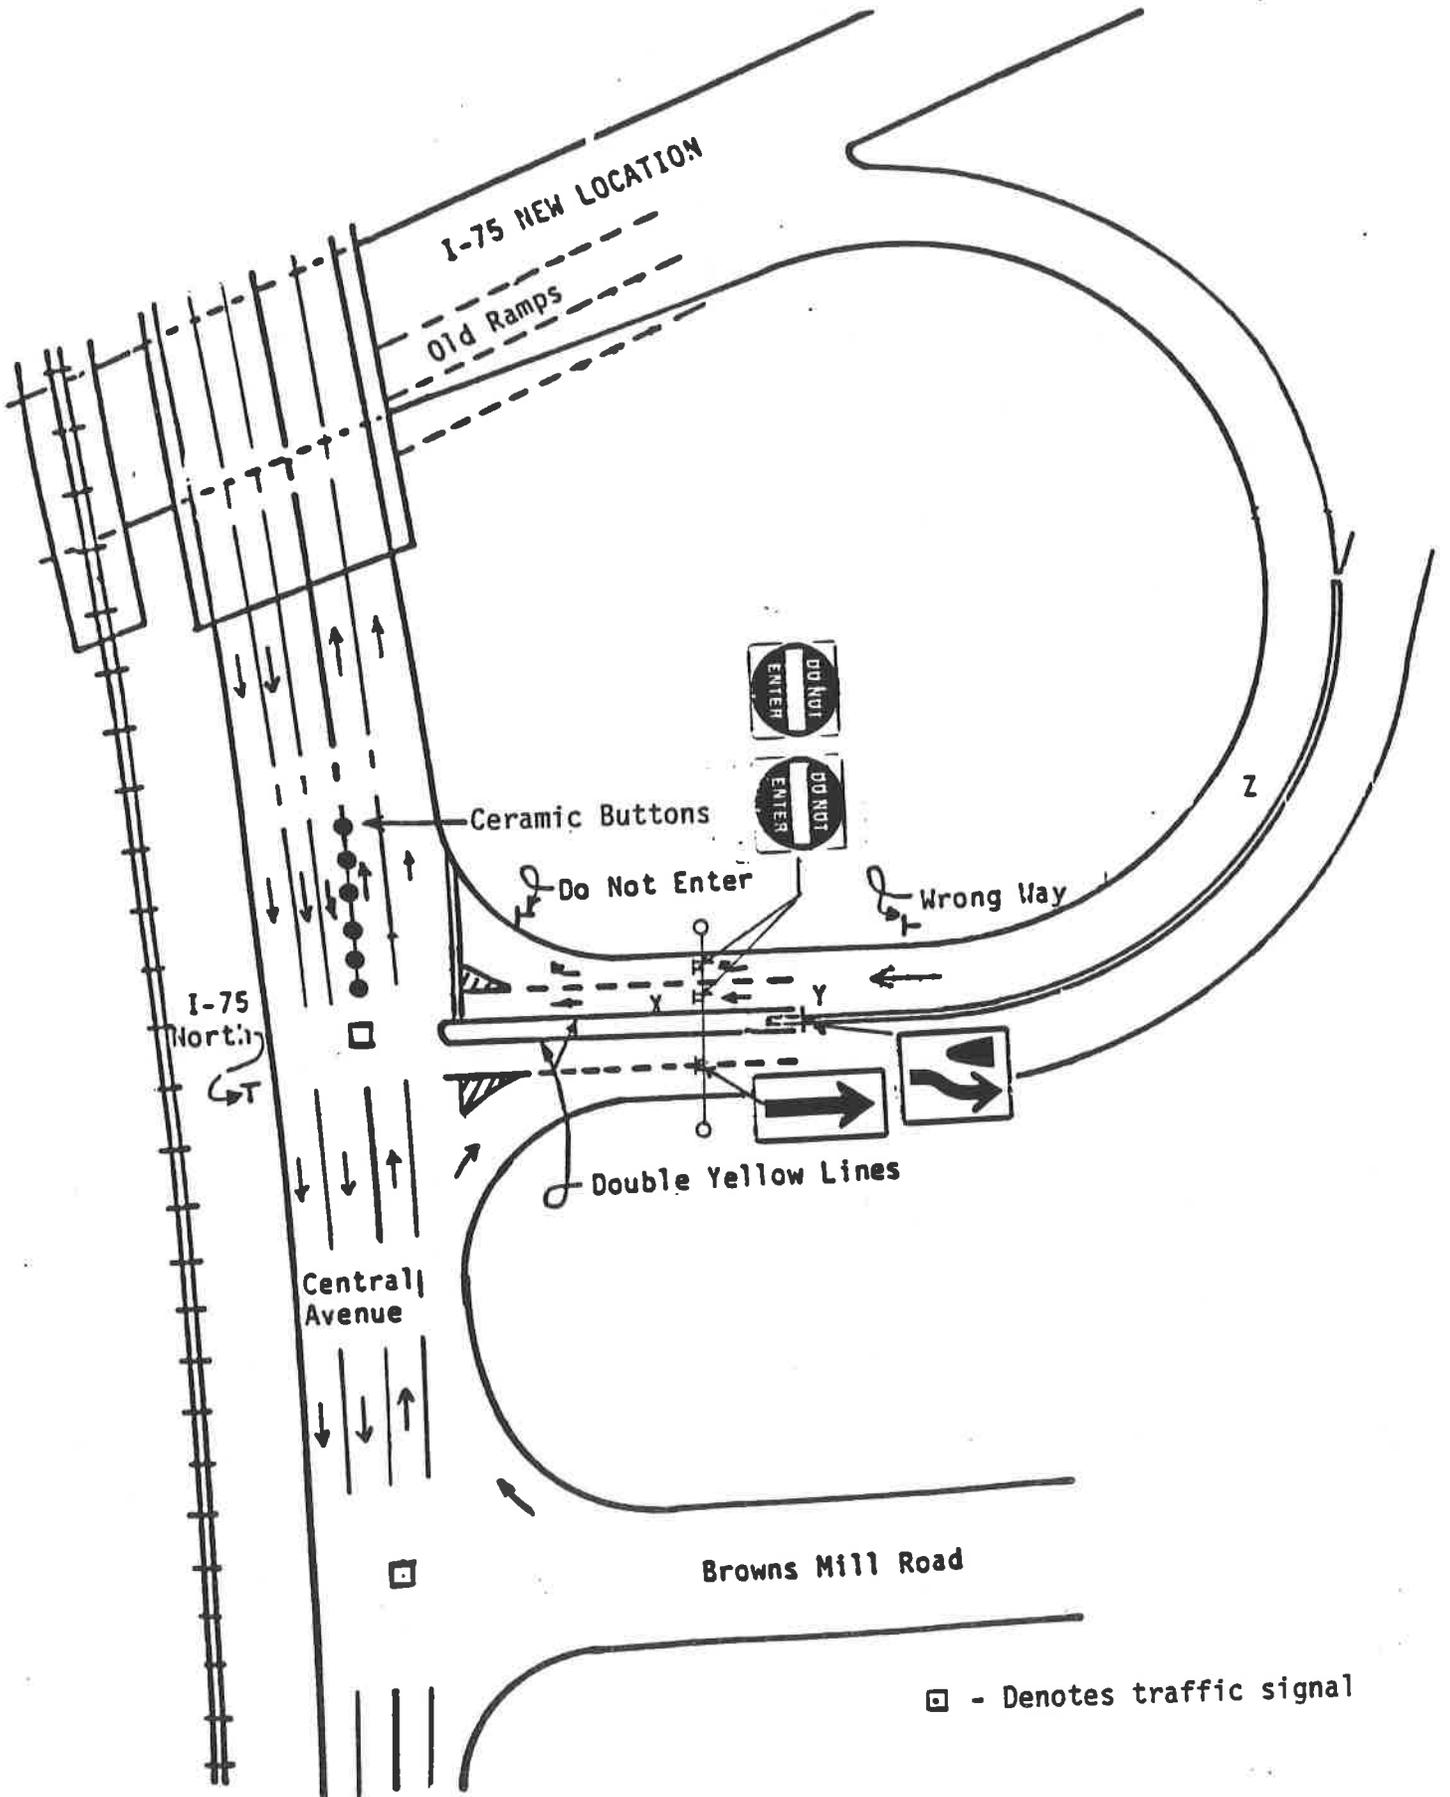
6. The following countermeasures should be added at Central Avenue (see page 24):
 - . Delineators replaced with eight inch yellow ceramic buttons.
 - . The "Keep Right" sign on top of the barrier wall facing on-ramp traffic to I-75 N.B. should be replaced.

- . Install overhead directional signs on signal wires for I-75 and Browns Mill Road.
 - . Add two (2) "DO NOT ENTER" signs on the back of existing signs located on Overhead Span Wire structure - facing On-Ramp Traffic.

- . Add a "Straight Ahead" lane designation sign on the existing Overhead Span Wire structure to be located over the on-ramp to I-75 N.B.

□ - Denotes traffic signal
